Failures of Fastening Screws and Their Preventive Methods

Fatigue failures of bolts, 2nd report

*Emeritus Prof. of Saga University
Shin-ichi Nishida*

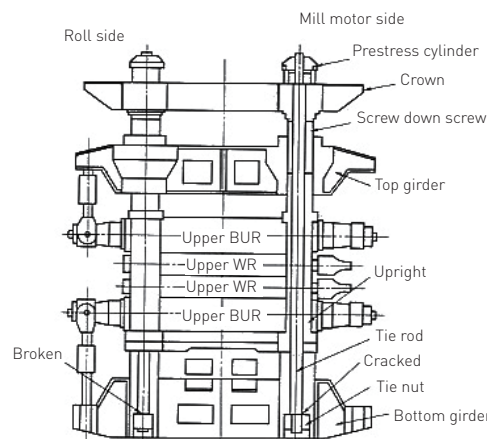
Fig.2.1 Schematic illustration of rolling mill and position of failure

The front view of a rolling mill and the position of failure in the mill are shown in **Fig.2.1**. The mill is designed so that the rolling reaction force is received by four giant bolts (called the tie rod: outside diameter of thread= $\phi 475\text{mm}$, body diameter $\phi 450 \times$ total length 13,975mm). Failure was detected in two out of four tie rods. One of the two tie rods was completely broken and cracks were detected in the other rod. This failure is shown schematically in **Fig.2.2**. In the two tie rods, failure occurred in the end section of the nut or its vicinity on the side where the material to be rolled is bitten. The material of the tie rod is SCM440. The chemical composition of SCM440 is listed in **Table 2.1**.

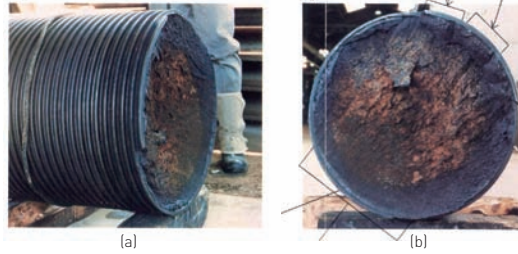
Fig.2.3 Fracture surface of tie rod [(b):Fatigue cracks are initiated inside of the frame]

The fracture surface is shown in **Fig.2.3**. For the most part of the fracture surface is brittle, while a smooth surface with a step is observed near the thread root. This surface is attributable to the fatigue crack which initiated at the thread root and propagated. Observation by SEM (scanning electron microscope) revealed the striation peculiar to fatigue (see **Fig.2.4**). After repair, the stresses were measured by strain gauges (single axis×5mm in length, four gauges) which were attached to the body of the tie rod. As a result, a maximum repeated stress amplitude $\sigma_{amax}=1.23 \text{ kgf/mm}^2$ and a mean stress $\sigma_m=17.7 \text{ kgf/mm}^2$ were obtained. When the coefficient of internal force ϕ is assumed to be about 0.2⁽⁸⁾, the amplitude of external force, F_{amax} , is estimated to be about 6.2 kgf/mm². As the tensile strength σ_B of the material is 80.7 kgf/mm², the fatigue limit is as low as about 1/50—1/60 of the actual tensile strength. The reason why the fatigue strength of large diameter bolts decreases sharply is explained later.

The maximum bolt failure in the world
↓ Compare to the man's foot

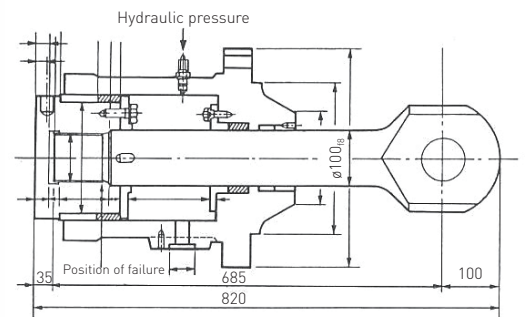
Fig.2.6 Schematic representation of cylinder rod (QT steel of S50C)

The cylinder rod of a hydraulic upsetter broke from the threads. The cylinder rod is shown in **Fig.2.6**. The macroscopic fracture surface of the rod is shown in **Fig.2.7**. The fracture occurred at

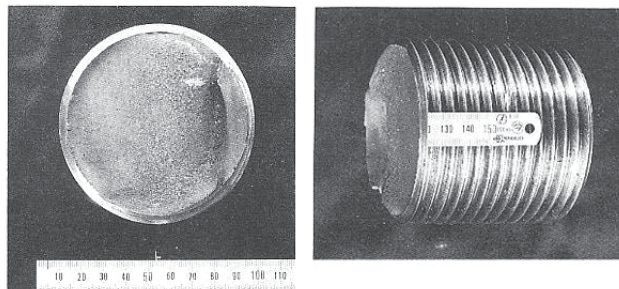
Fig.2.7 Failure of cylinder rod of upsetter

the end of the engagement with internal threads. The material of the rod is S50C (quenched and tempered steel). As is apparent from the macroscopic fracture surface, the ratio of the fatigue fracture surface is very high. It is therefore estimated that the repeated stress amplitude σ_a is close to the fatigue limit of the bolt. The number of cycles to failure actually measured, N_f , is 25×10^4 cycles. With QT steels, striation is not always clearly observed on the fracture surface under SEM. Accordingly, an example of analysis from the fatigue strength (S-N diagram) is described below.

First, the fatigue limit of the screw now in use is estimated. In the case of screw M90, the root diameter of the thread is $\phi 83.5 \text{ mm}$. As a load P of 0-57.4 tf (a constant amplitude of load generated by hydraulic pressure) is repeatedly applied, the nominal stress amplitude σ_a is calculated as shown below:

Taking the size effect into account, it is estimated that the fatigue limit of the screw is lower by about 20% than that of a standard bolt M24. If the value calculated by equation (2.1) is converted into the value for an M24 bolt, the stress amplitude

The S-N curve of a normal bolt is shown in Fig.2.8. When the stress level is as calculated by equation (2.2), the number of cycles to failure, N , is 40×10^4 cycles. The order of this number is the same as that of the number of cycles to failure actually measured, $N_f = 40 \times 10^4$ cycles.

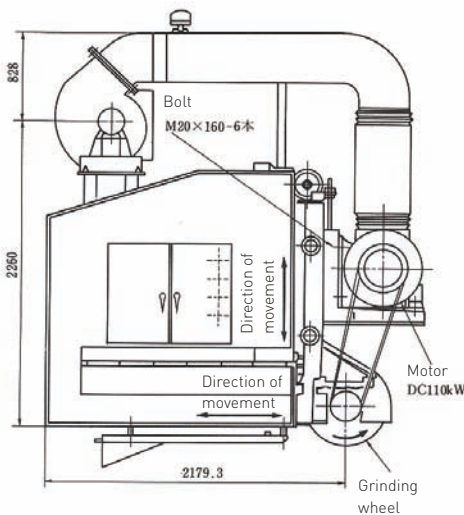
Fig.2.9 Schematic illustration of grinder (side view)

There are cases in which repeated stress is not apparently applied to the bolt or in which it is difficult to predict the stresses to be applied to the bolt at the design stage. An example of bolt failure in such cases is described below. A grinder is shown schematically in Fig.2.9. Bolts are used in many places in the grinder. The bolt most likely to be broken is the bolt (M20×160mm in length, six bolts) fixing the motor. A grinder wheel is located beneath the motor. A grinder wheel is located beneath the motor (DC110kW). The motor is connected to the grinding wheel with four V-belts. The motor and the grinding wheel are fixed on a common slider which is designed to move up and down. The billet is sent under the grinding wheel as if it crosses the wheel, and the billet surface is partially ground by the wheel.

Apparently, little repeated load is applied to the motor fixing bolts. In practice, however, the impact force produced when the grinding wheel comes into contact with the billet is transmitted through the V-belts to the motor, as a result of which fluctuating loads are applied to the bolts. Moreover, the vibrations resulting from the rotation of the motor, V-belts, and grinding wheel are applied to the bolts in addition to the fluctuating loads.

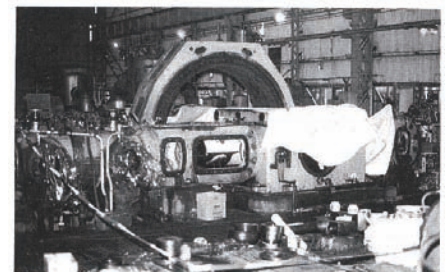
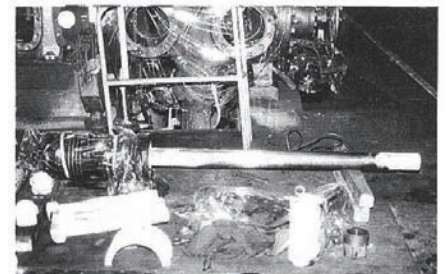
Fig.2.11 Outer view of compressor piston rod

If one thread of a bolt is broken, the breakage may spread to other parts in succession. A good example is the failure of a compressor piston rod. The compressor is of the double acting type (about 2,000 kW). As the screw (M90) of the piston rod on one side was broken, the crank shaft lost its balance, resulting in failure of the balance weight shear pin, bearing clamp bolt, connection rod, and compressor casing bed in the order mentioned.

The compressor piston rod (reciprocating type) is shown in Fig.2.11. Shown here is the piston rod on the side which was not broken. The color check of the rod did not reveal fatigue cracks. The fracture surface of the piston rod is shown in Fig.2.12.

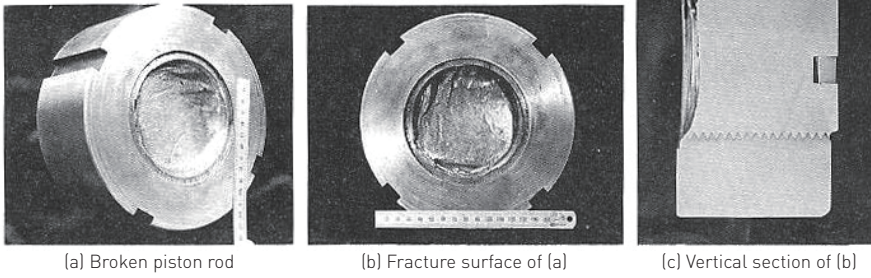
Fig.2.12 Outer view of fracture surface of compressor piston rod

Figure 2.12(c) is the longitudinal cross section of the rod shown in Fig.2.12(b). The failure of the piston rod occurred from the end section of the nut. As the piston rod is of the reciprocating type, its fracture surfaces were severely struck by each other and could not be used for observation. Quite a long crack was observed at the root of the twelfth thread, counting from the end section of engagement with the nut (see Fig.2.12(c)). It may be said that the design of the threads of the piston rod is quite reasonable. The material of the piston rod is SNCM625 (quenched and tempered steel, the tensile strength $\sigma_B = 94.4 \text{ kgf/mm}^2$). When the rod was broken, about five months were required for complete repair.

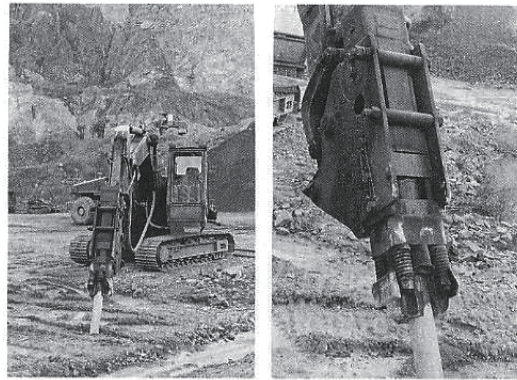
Fig.2.13 Outer view of chisel holding bolts of a large stone crusher

which the chisel holding bolt was broken. **Figure 2.13(b)** shows the setting condition of the bolt (M50×length 1,200 mm). **Figure 2.14** shows the appearance and fracture surface of the bolt. Four bolts make one set. It is considered that the reciprocating motion of the chisel and the impact force transmitted through the chisel are applied to the bolts. The bolts were broken during a period of six months to a year, although the duration varies depending on the method of use.

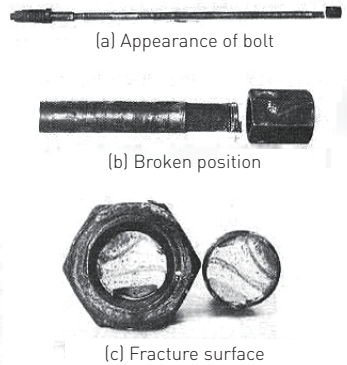
Fig.2.14 Chisel holding bolt of large stone crusher

The beach mark which is characteristic of fatigue is clearly seen in the fracture surface shown in **Fig.2.14**. The ratio of the fatigue fracture surface is higher than 80% and the fracture surface is smooth and nearly free from steps. It is therefore, considered that the repeated stress is close to the fatigue limit.

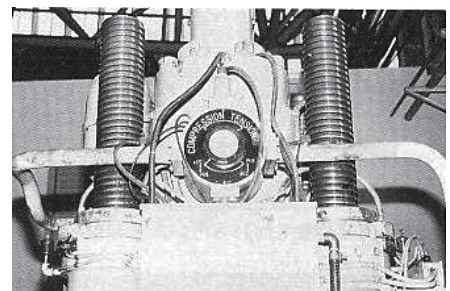
Fig.2.16 Hydraulic actuator of universal fatigue testing machine

Figure 2.16 shows the hydraulic actuator of a universal fatigue testing machine. In the actuator, eight bolts each are used for the top and bottom covers (double end, W1-1/4). As oil leakage from the bottom cover was detected, the bolts for the bottom cover were checked. As a result, failure of three out of eight bolts was detected. The fracture surface of the set bolt of the actuator holding cover is shown in **Fig.2.17**. A fatigue fracture surface is clearly seen all over the surface. The failure occurred from the end of the engagement with internal threads. The material of the bolt is SCM435 (quenched and tempered steel).

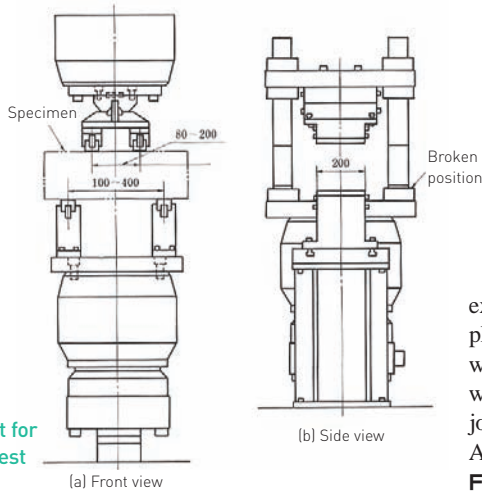
Fig. 2.19 Equipment for repeated bending test

As described in 2.7 above, fatigue failure of the members may occur even in the fatigue life is closely examined at the design stage. A jig for the reversed bending test and an example of failure of the jig are shown in **Figs.2.19** and **2.20**, respectively. The bolt is M85×750mm in length (root diameter:φ78.5mm). Failure occurred from the rod end section of the internal threads. The material of the jig is SCM435 (quenched and tempered steel).

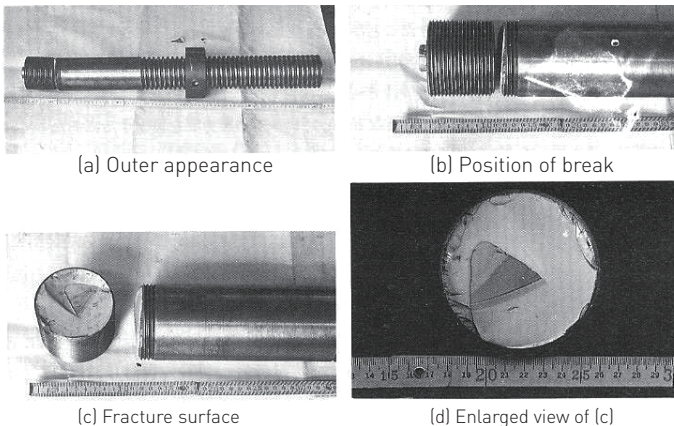
Fig.2.20 Broken position of repeated bending equipment (column)

As the reaction force in three-point bending is applied to the bolt (column), it is considered that not only a tensile stress but also a bending stress were applied to the threads. This is evident from the fracture surface shown in **Fig.2.20(d)**. The failure occurred on the triangular thread side. The reason why failure did not occur on the square thread side (right-hand side of **Fig.2.20(a)**, root diameter:φ72.4mm) in spite of the smaller root diameter is that the position of engagement with the nut on the square thread side is changed at regular intervals for adjustment. When a repeated load is applied, one of the simplest methods for improving the fatigue strength is to change the position of engagement with internal threads at regular intervals, although this method is not widely employed. A beach mark was not observed on the fracture surface of this bolt. This shows that the test was conducted with nearly constant stress amplitude.
