Fastener Failures Due to Heat Treatment: A Case Study

by Daniel H. Herring

Case Study – Root Cause: Bad Heat Treatment

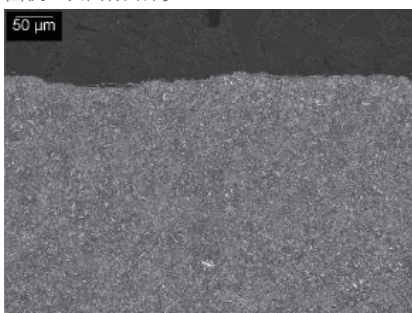
(a) Surface microstructure of "good" sample revealing thin oxide film at the surface.
良好样本表面呈现薄氧化膜的表层微结构。

The "good" fasteners exhibited a surface and core microstructure of tempered martensite, the result of proper heat-treating. A thin oxide layer was observed on the part surface indicative of tempering at elevated temperature in air.

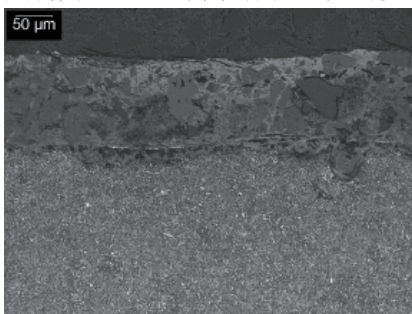
(b) Surface microstructure of "bad" sample revealing thick oxide film at the surface.
不良样本表面呈现厚氧化膜的表层微结构。

In addition, an examination of the cross section of both the "good" and "bad" fasteners was also performed. The result of the analysis was a microstructure of tempered martensite. A continuous film that is approximately 100 microns thick was observed on the exposed surfaces and fracture cross sections of "bad" fastener. In contrast, the surface film on the "good" fastener was approximately 2 microns thick.

Corrective action, in this instance, consisted of instructing the commercial heat treater to not rework but quarantining any fasteners that were subjected to an abnormal heat treatment cycle until a thorough metallurgical analysis could be performed. Furthermore, using a dye penetrant or similar method for determining the presence of cracks after heat treatment was also suggested. Using an independent source, routine (per batch) quality checks could be performed by an independent third party. Finally, in-house heat-treating is an alternative that might be considered if the problem is found to persist despite the quality control measures suggested. ■

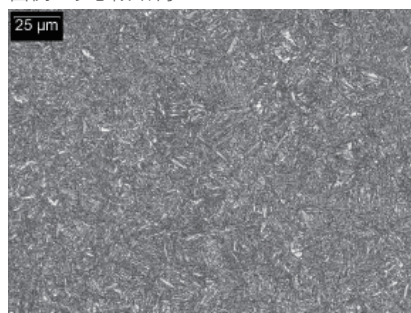
(a) Core microstructure of "good" sample consisting of tempered martensite.
由回火麻田散铁组成的良好样本砂心微结构。

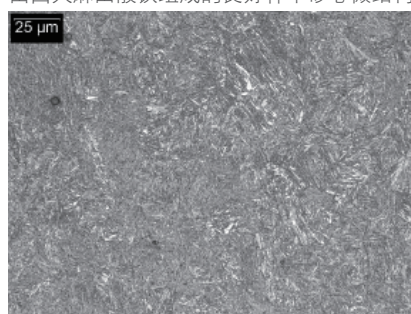
(b) Core microstructure of "bad" sample consisting of tempered martensite.
由回火麻田散铁组成的不良样本砂心微结构。

The "bad" fasteners were cracked during the heat treatment process, either the result of thermal or quenching stresses.

Hardness values (converted from microhardness measurements) on the "bad" fasteners found were out of specification (high) indicating an inconsistency in response after the re-hardening operation.

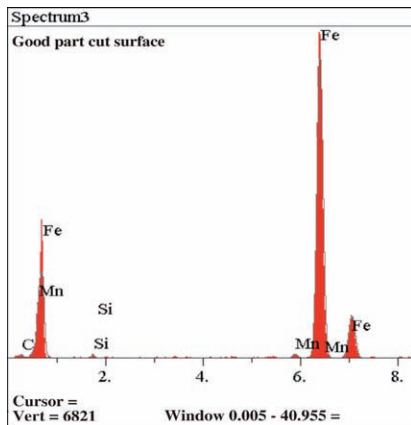
(a) Baseline EDX results
 基线能量散射光谱仪结果。

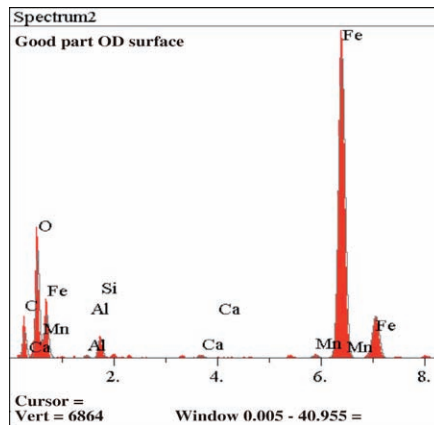
(b) EDX results on the OD surface of the
 "good" sample.

and the baseline material were analyzed for comparison with the "bad" part. Less oxidation on the "good" fastener outer diameter surface was determined in the analysis. The material was identified as SAE 1045 steel based of analysis the sectioned insert wall.

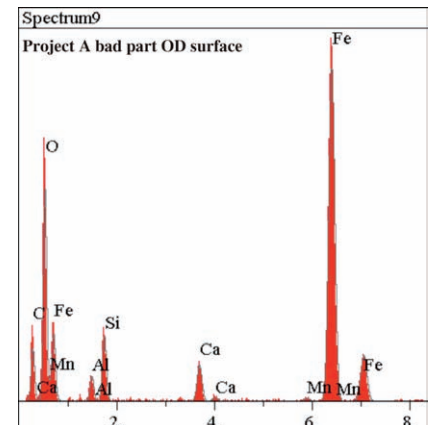
(d) EDX results on the OD surface of the
 "bad" sample.

The fracture surface of the "bad" fastener appeared uniformly black - the same color as the exposed surfaces on the "bad" part. SEM / EDX analysis was performed on both the fracture surface and the exposed OD surface for comparison. Both of the analyzed "bad" fastener surfaces revealed continuous coverage with the oxide film with identical elemental composition.

The fracture surface and the outside diameter of the fastener both yielded the same composition and oxide layer thickness.

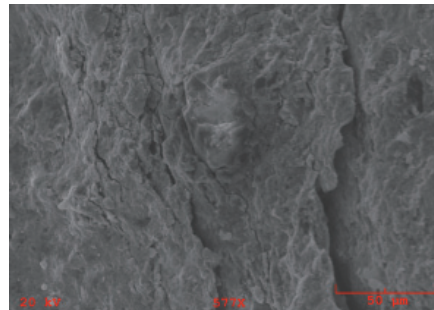
(c) SEM view of surface of "good" sample.
 良好样本表面的扫描电子显微镜 (SEM) 视图。

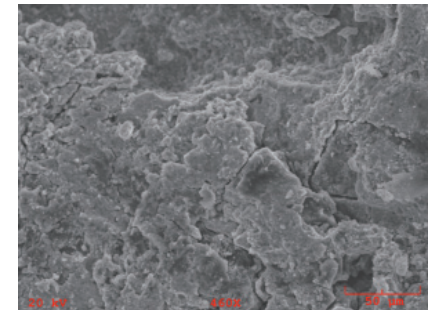
(e) SEM view of surface of "bad" sample.
 不良样本表面的扫描电子显微镜 (SEM) 视图。
