Identifying Fastener Failures

by Guy Avellon

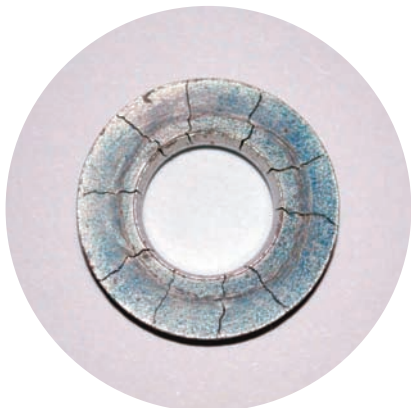
Pic. 1. Hydrogen embrittlement

The reverse side of this flat washer is stamped with a manufacturer's identification and size. This stamping alone creates residual stresses, but this washer was a high carbon steel that was heat treated to a hardness of Rc 44, then electroplated.

Platers do not know the hardness of the products they process, so without special instructions they will perform the same tasks as usual; acid pickling and electroplating without post baking. Many times the current is increased to increase productivity and quickly add thickness, but in doing so, an increase in hydrogen gas is formed and becomes trapped to release its energy at a later time.

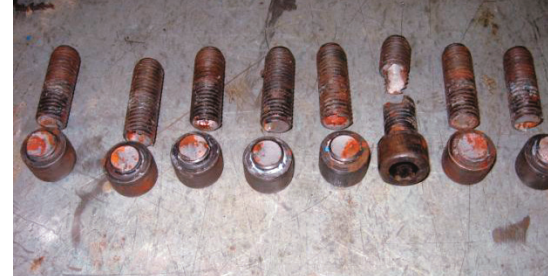
This next photograph shows eight fractured socket head cap screws. Now, clearly these are fatigue fractures, but the patterns can be applied to other application fracture cases as well.

Pic. 5. Screws of fatigue fracture

In the above photograph, the fastener with the head still attached was the last to fail. It broke in tension at the threads in the grip zone. The others failed at the head as the application was supporting a die ring that was under high pressure that cycled. The head on this fastener would have failed also but the others had weakened the connection clamp load so much that this lone fastener was carrying the majority of the load until it failed in tensile.

The progression of the fatigue fracture across the surface of the steel will indicate how long the microcrack had been propagating before the tensile failure occurred. For example, the fourth from the left was the first to begin failing. This is because the fatigue fracture had propagated nearly completely across the cross section of the cap screw. As one begins to lose clamping load, the stresses are moved to another fastener, usually the adjacent fasteners, who begins to develop their own stress cracks. Their crack propagation is a little less than the first. And the cycle progresses to the other fasteners in the connection; each one has a little less progression than the previous cap screw.

In this case, the cap screws were not torqued evenly, in a criss-cross pattern nor in a sequence.

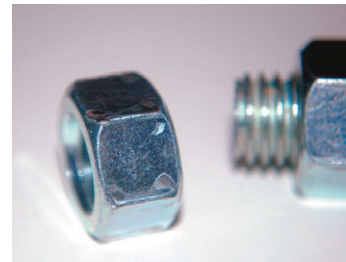
When taking a closer look at the wrenching corners of the nut, it is clearly evident that a power wrench was used for assembly. There are indentation markings on the corners of the nut in the 'on' position. There was some back-lash of the wrench that caused the mark on the opposite corner (top) of the nut.

Pic. 10. Indentation markings on the nut

The back-lash is also caused by a high assembly speed; the faster the speed the greater the compression of the joint which rebounds in relation to the compression relaxation. In this case, the fastener was being tightened against a metal plate and wood, which increased the compressibility and rebound.

Although not mandatory by the ASTM A307 standard, the manufacturer can stress relieve the fasteners, which would minimize any potential damage to the head during installation. The installer could be less aggressive with the speed wrench and watch for any accidental lubricants on the threads. Lubricants will greatly reduce any assembly friction and cause more tension than torsion. ■
