Fastener Failure Analysis

by Guy Avellon

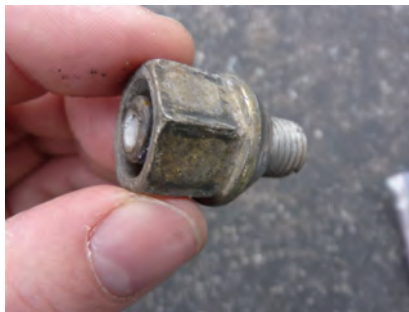
Fig. 6. Impact wrench effect on a nut

The impact wrench will always leave tell-tale signs of abuse. In the photograph above, the hex corners of the nut clearly displays markings from the socket on the installation side (right) of the hex corners. There are also markings on the off-side (left) which appear not only from removal but from the recoil of the socket as the impact goes forward and instantly recoils back.

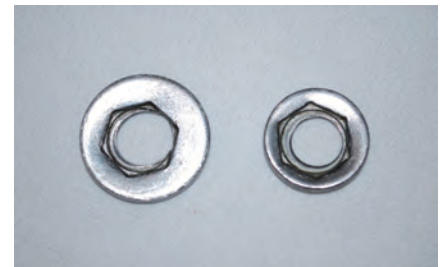
Fig. 7

Clamp load is also lost if a wrought flat washer was used with a Grade 5 (8.8 metric) bolt or higher. If the washers have indentations, clamp load was lost. The washers in the following photograph have caused a massive loss of clamp load. Metal

fatigue from this lost clamp load will cause a rapid bolt failure.

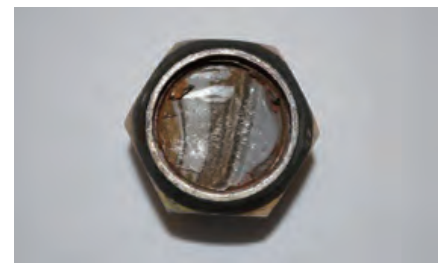
Fig. 8

Some corrosive environments can lead to stress-corrosion-cracking, where the grain boundaries become under chemical attack. Standing water will set up an electrolytic cell and cause hydrogen embrittlement.

Other times, when there is rust in the fracture zone, it can signify that the failure was not new and had been propagating for some time. This could also cause other stress initiation sites.

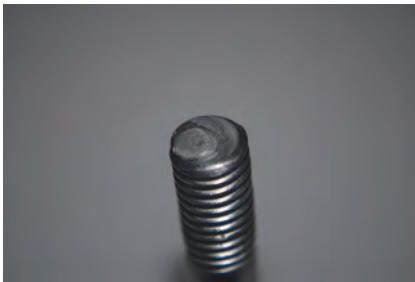
Fig. 9. Failed stainless steel

Agricultural machines come under heavy chemical attack, even if properly washed down every day. Some have replaced their OE bolts for stainless steel to avoid the frequent replacing of rusty bolts. Unfortunately, in some cases the stainless steel bolts will fail in a bending mode and metal fatigue because they weren't as strong as the OE bolts they replaced.

A large agricultural spraying tractor had several failed stainless steel bolts. All exhibited some form of bending. The fracture surfaces were typical of metal fatigue. The customer replaced his corroded bolts with stainless steel to avoid frequent replacement. No further information was provided.

Not knowing what the original fasteners were, the parts catalog for the manufacturer of the farm implement was downloaded. It was discovered that many of the OE parts were flanged head bolts and nuts. The nuts were Grade C, which meant these were lock nuts with a proof load of 180 ksi. The stainless steel used had a tensile strength of 100 ksi, but the yield strength was only 60 ksi. Clearly not as strong as the recommended OE fasteners. ■

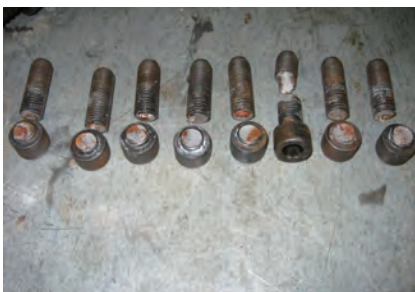
Fig. 10

Load distribution in a joint with several bolts can be a problem if not evenly tightened. When this occurs, the entire joint begins to lose clamp load and the least tightened fastener is subjected to metal fatigue stresses. Then, because of the loss of the overall load capability of the joint, the adjacent bolts are exposed to extra stresses to compensate and a domino effect occurs.

The fracture surfaces will indicate which bolt failed first and last by the progression of the fatigue crack. The first to be exposed will have the crack propagate through the most

area, and then the second will not be as advanced and so forth, until the last failure(s) could be in ductile tension, (third socket screw from the right).

Also note areas of rust in the fracture area. This will indicate age by its progression. The rust will be a significant indicator in some instances to prove prior or existing damage to the bolt if that bolt was recently reused or tightened with another nut and then suddenly failed in an application.
