by Jozef Dominik

# Dangerous Plagiarism Under Fasteners

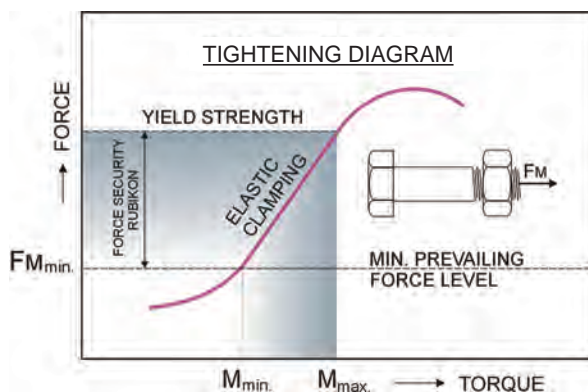
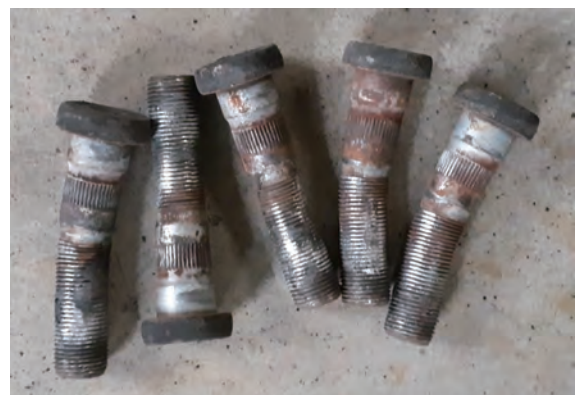
Assembly parameters of screw connections are among the most important design decisions. These parameters depend on the property class of the screws (Table 1). In diagram Fig. 1 is the “force security rubikon zone” that defines the conditions for assembly and operation. This zone must not be exceeded! Breach to observe this condition may result in destruction of the screw connection.

In Fig. 3 is a bolt screw found on the road to the unknown driver from the car. A broken thread is clearly visible which would indicate excessive tightening; it means over force security zone (Fig. 1). This is sometimes the case for unprofessional assembly. However, a strong mark on the head of this screw is striking (Fig. 4 and 5). In addition, there is no manufacturer's identification mark. Immeasurable HRC hardness values have only confirmed the suspicion that it is a fake!

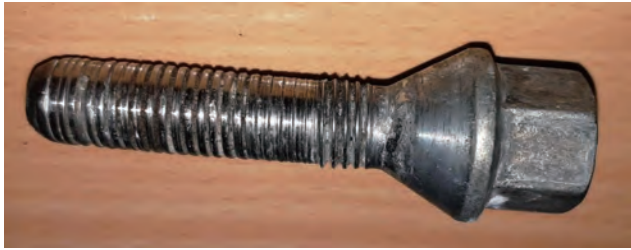
Fig. 2

Vehicle overloading results in deformation of the wheel fastening bolts (Fig. 2) and subsequent gradual release of the wheel. The nature of this deformation depends on the size of the external load on the vehicle and on the strength characteristics of the bolts.

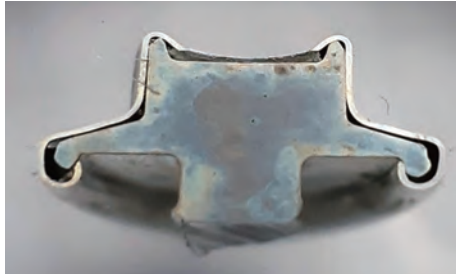
The case in Fig. 6 does not need a comment. The pressed stainless steel thin sheet on the self-drilling screw head impresses with stainless steel screws (Fig. 7). The difference is almost imperceptible to the naked eye. The user will recognize it after a certain period of operation when the first signs of corrosion appear. For reasons of objectivity, it must be added that such a construction may be acceptable. However, it must be officially declared.
