Fastener Corrosion in Treated Lumber

by Laurence Claus

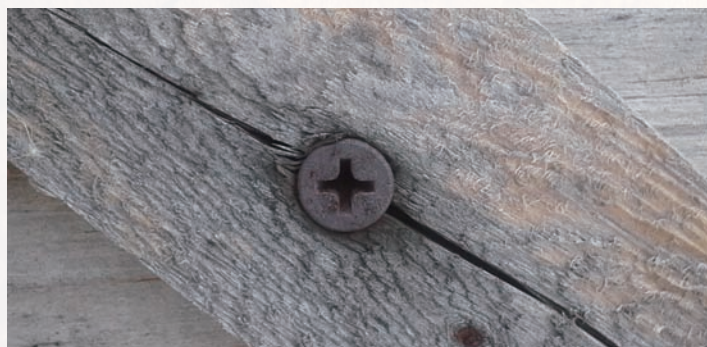
Figure 1: Zinc Plated Fastener Example in Alternate Treated Lumber After Several Years Exposure

With the exception of the SBX treatments, experience has shown that the alternate treatments, ACQ, CA, and MCQ all are much more corrosive to metallic fastening elements than the CCA treatment. Although the actual mechanism of corrosion is still unknown, it is theorized that the greater concentration of copper and absence of hexavalent chromium in these alternates is a significant contributing factor. Hexavalent chromium is a proven corrosion blocker and was an integral part of many corrosion protection systems up until about fifteen years ago when it was deemed a hazardous substance.

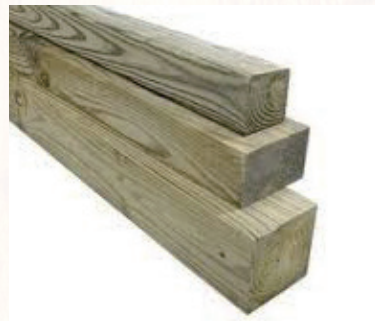
Figure 2: Typical ACQ Treated Timber
图2、典型的铜烷基铵 ACQ 防腐木材

CCA has been replaced by a variety of different treatments. In the United States the most common alternate treatments are Alkaline Copper Quaternary (ACQ), Copper Azole (CBA and CA), Sodium Borate (SBX), and Micronized Copper Quaternary (MCQ). ACQ is a combination of about 2/3rd copper oxide and 1/3 quaternary ammonium compound. Like CCA, there are several different standards that exist for ACQ, Types B, C, and D. ACQ-B is the most prevalent treatment in the United States because of its improved ability to penetrate certain western species of US pines. CA-B or copper azole type B is used in the United States and is a waterborne solution of 96% copper and 4% tebuconazole. SBX or borate treatments are generally reserved for timbers being treated for termite or other insect infestation hazards. Most borate treatments use disodium octaborate tetrahydrate because of its excellent water solubility which facilitates the application of more concentrated solutions. Their lack of copper constituents generally makes them unsuitable for prolonged wet conditions and so they are usually used in “dry” applications. Finally, MCQ utilizes micro-sized particles of solid copper rather than aqueous copper like its close cousin, ACQ.

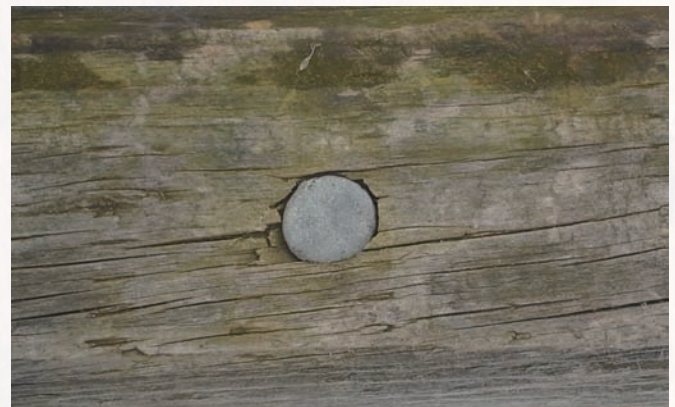
Figure 3: Hot Dipped Galvanized Fastener Example in Treated Landscape Timber after Several Years Exposure
图3、热镀锌紧固件暴露于处理的景观木材数年后的实例

Hot dip galvanized fasteners can exhibit different rates and subsequent levels of corrosion based in the thickness of the zinc layer. As a result, Simpson Strong-Tie recommends a thicker version of hot dipped galvanized metal connector when exposed to certain environments or contacting the alternate treated wood addressed in these studies. In addition to hot dipped galvanized fasteners they also recommend austenitic stainless steel, but caution that best practice dictates not mixing dissimilar materials. In other words, if using hot dip galvanized connectors, the fasteners should also be hot dip galvanized and stainless connectors should use stainless fasteners.

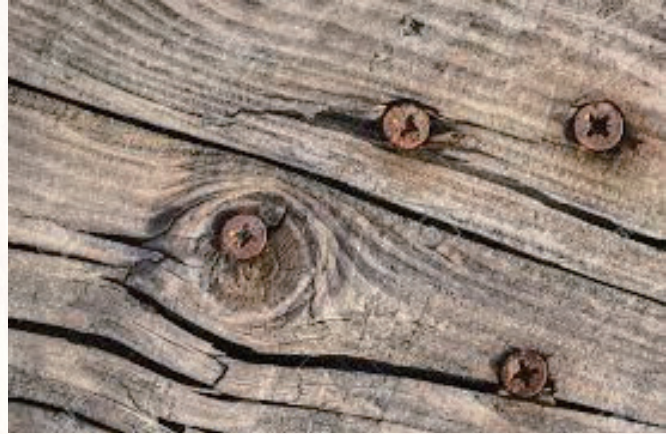
Figure 4: Example of “Nail Sickness”
图4、钉子疾病的例子

The BRANZ study also goes on to recommend that when specifying the fastener one must consider the entire joint holistically. The report points out that, “Deterioration of metallic fasteners not only weakens the fastener itself, but the chemical reactions involved in corrosion can also weaken the timber surrounding the fastener.” They refer to this as “Nail Sickness” and, as a result, suggest that the fastener and timber be considered as a system to minimize any risks in structural safety or longevity.
