In this episode, I will stress on the importance of quality control and talk about a case where an end user submitted a successful claim to a manufacturer. Today's topic is Drop-in Anchor.

# Drop-In Anchor: A Case Study on Claim Settlement

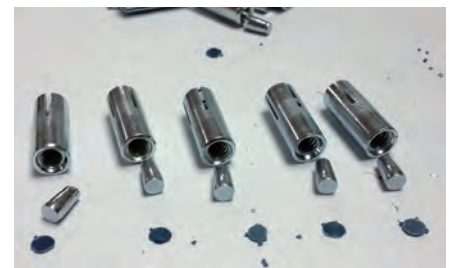
He wrote an e-mail and explained, "The anchors were shipped from Plant A of your company. **Picture A** indicates core of the detected problem. We have also verified that the anchors originated from your Plant A. When

the anchors were taken out of the package box, I found loosened dilating plugs in one third of your anchors."

Picture A: Loosened dilating plugs and plastic plugs.

A week later, the client received the sample. The manufacturing division of Plant A fully agreed with the problem found by the client. Based on the investigation, onsite operators made an unforgivable mistake during plastic plate insertion, causing loosened dilating plugs. The plant manager has ordered involved manufacturing units to run self-examination and punishment. To prevent the problem from reoccurring in the future, we have changed to another way of assembling (see **Picture E**). We inquired the client for all the cost for manual sorting.

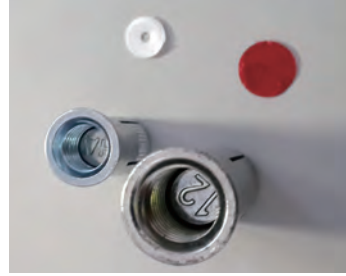
Picture C: Before assembly. Diameter of the red and white plastic plate should be larger than the diameter of the dilating plug.

assembled (see **Picture D**), the diameter of this plastic plate must be larger than the anchor's internal thread diameter (see **Picture C**). During assembly, the plastic plate will reach the anchor point and hold the dilating plug within the drop-in anchor (see **Picture B**). There is no way that the wedged cylinder can loosen unless the incorrect plastic plate is inserted. If the loosening does occur as described by the client, I suppose something must be wrong with the plastic plate.

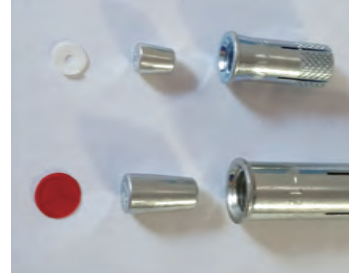
Picture D: Drop-in anchor before assembly where the plastic plate is not yet inserted.
