Dangerous Plagiarism Under Fasteners

by Jozef Dominik

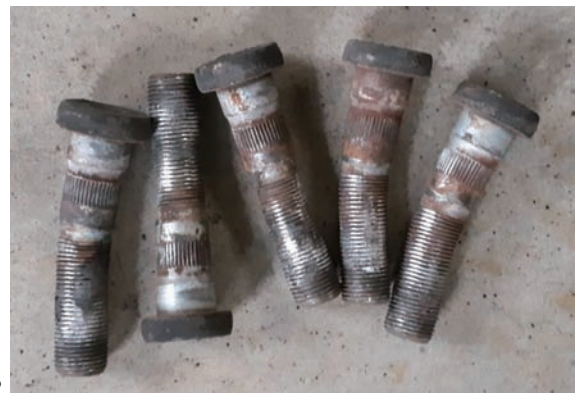
Fig. 2

Vehicle overloading results in deformation of the wheel fastening bolts (Fig. 2) and subsequent gradual release of the wheel. The nature of this deformation depends on the size of the external load on the vehicle and on the strength characteristics of the bolts.
