Fastener Failures Due to Heat Treatment: A Case Study

by Daniel H. Herring

Case Study – Root Cause: Bad Heat Treatment

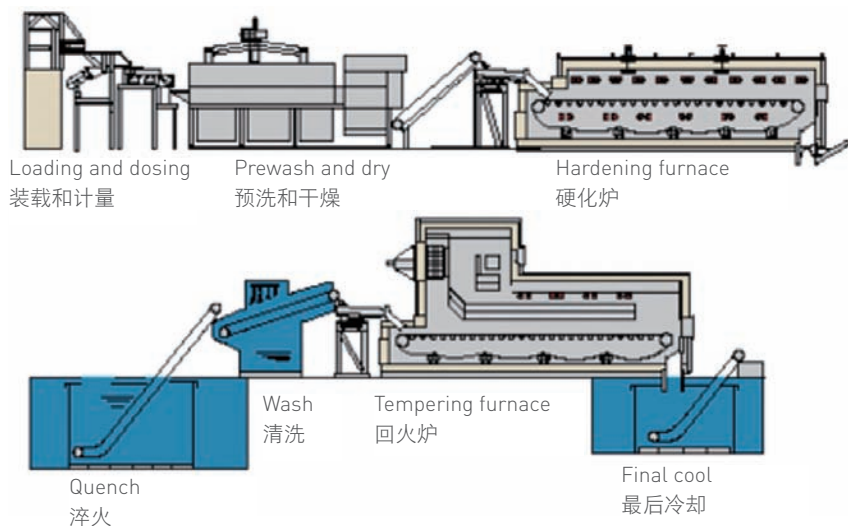
Figure 1. Typical Mesh Belt Furnace System with Oil Quench Capability
图例 1 典型具油淬火性能的网带炉系统

Ten out of sixty SAE 1045 fasteners were found to be cracked after heat treating in a continuous mesh belt furnace line (Fig. 1). The heat treatment called for austenitizing at 870°C (1600°F) for 30 minutes, oil quenching and tempering at 370°C (700°F) for two (2) hours.

During the investigation the commercial heat treater running the job reported a power outage (due to a lightning strike during an electrical storm on a local substation) that occurred while the parts in question were being heat treated, resulting in a loss of furnace atmosphere and temperature. Parts were subsequently unloaded, hardness tested and found to be low in hardness and re-run in an attempt to salvage them. Subsequent hardness testing indicated they were within specification.
