# Why Automobile Wheels Fail

by Guy Avellon

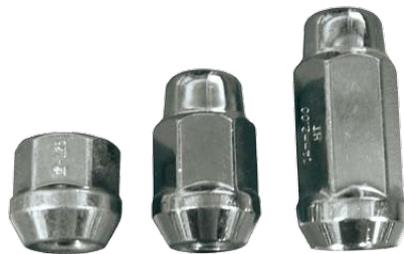
Fig. 1 Short and long nuts carried by distributors

Fig. 2 Nut with thrust washer

Fig. 3 Typical Wheel Stud with a ribbed neck

Distributors of automotive hardware will carry a variety of wheel nut styles. This would include a short nut, medium length nut and a longer wheel nut (Fig. 1). In addition, some wheel nuts will have a washer attached for use with some alloy wheels (Fig. 2). The other variety of wheel nuts will have a round or conical end which is designed to fit into the concave seat, or piloting hole, of the wheel to firmly engage the wheel to clamp it both axially and radially.

Wheel nuts are naturally meant to mate with wheel studs. The studs have a flanged bearing head with a ribbed neck body (Fig. 3). The ribs provide an interference fit with the wheel hub or disc brake and must therefore be installed by a hydraulic press. Many new disc brake kits will already have the wheel studs press-fit into them. However, none of the kits are supplied with new wheel nuts. Currently, all wheel studs are made to meet either SAE Grade 8 or ISO 10.9 strength standards.

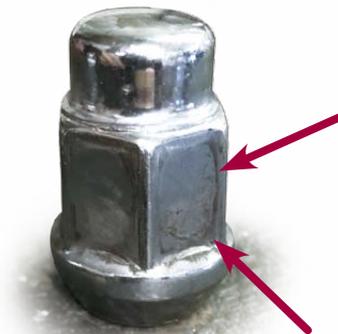
Fig. 4 Abused wheel nut having markings

The wheel nut pictured below (Fig. 4) has been abused with many removal and remounting applications. The markings indicate where the impact wrench socket hammered into the sides of the wheel nut leaving impressions on both the 'on' and 'off' direction. Many times, thread damage is not visible because the damage creates thread interference and friction when the parts are mated together. Other times it is very visible as in Fig. 5.

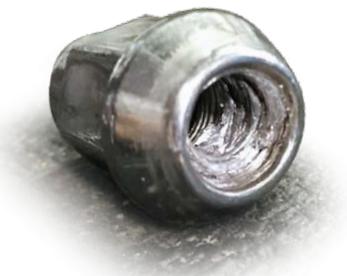
Fig. 5 Thread damage on the nut

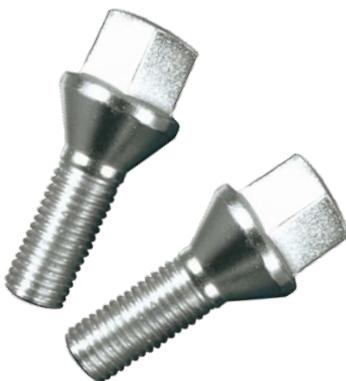
Fig. 6 Wheel Stud Bolts primarily found on European cars

Another piece of wheel hardware not mentioned yet is the wheel stud bolt. These bolt the wheel directly onto the wheel hub by threading either into the hub or brake rotor. These wheel fasteners are primarily found on many European vehicles; BMW, SAAB, Volvo, Volkswagen, etc (Fig. 6). Their tendency to fail is much less than that of a wheel nut, but its proper mounting is very critical.
