Cross Threading

by Thomas Dopke

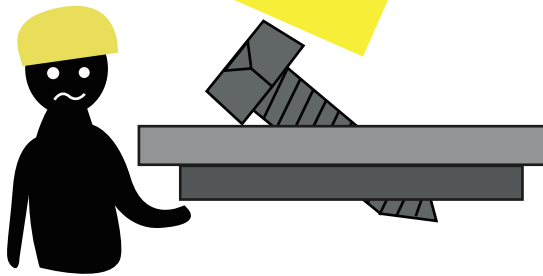
It took the 1,000kg tool but IT \nless in!!!

The bolt is installed with a "running start", run to the turn off setting of the tool (which is the specified torque) and on to the next one. Cross threaded fasteners can, as mentioned, be driven until the tool stops but the tension required to maintain the joint integrity is not present. Field failures, poor quality and irate customers will follow!

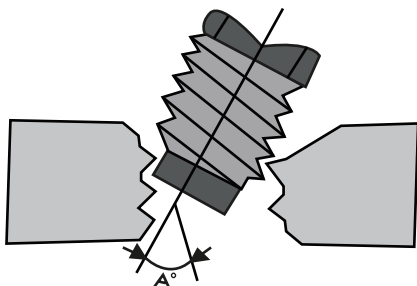
Cross threading occurs when the parts come together at an angle. As the illustration shows, as the length of the non-threaded section of the fastener (the 'pilot end' increases the angle A°) at which the threads may engage becomes less and less.

Most current parts can engage (cross thread) somewhere around 5 degrees off perpendicular (normal to the internal thread). How much of an angle was the basis of the study along with a detailed examination of the thread starting site. Axial misalignment, where the centerlines of both threaded sections are parallel but not concentric has been discussed above. The use of fasteners with some sort of protrusion, usually an AC cone threaded point, as a pry bar is used but damages the threads resulting in stripped and damaged threads. The cause and result of this condition is known.

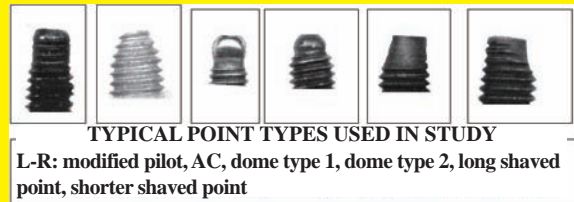
Using a test stand built to run at a constant speed and with a consistent weight end load, 25 samples of each point in M6 and M8 diameters were run at 5 different angles (7, 9, 12, 15, and 25 degrees) into a fixture which allowed movement for the engaged fastener to fully drive if it could engage. During the testing two conditions occurred: Cross threading, defined as a stopping of the installation action due to the threads jamming, and 'No Start' defined as those attempts where the fastener did not institute threading at the addressed angle but spun in the hole. Although 'No Starts' were not especially considered failures as an operator on the assembly line would know that the part did not engage and would wobble it until it did, these post attempts could still result in a cross thread situation.

All of the available points were of two basic design types: an extension on the end (pilot, dog point or some modification of the same) and a shaped feature, generally of a ramp like construction. AC points and current dog point design were also included for comparative purposes.

-Almost all points showed few cross threaded parts and few 'No Starts'. The entire amount of failures was from 7 particular points. As the angle of installation increased the number of No Starts and cross threaded parts increased until at 25° all but 3 part point types were No Starts. Of the 3 points that passed two were shaved ramp styles.
