Fixing Failed Fasteners

by Thomas Doppke

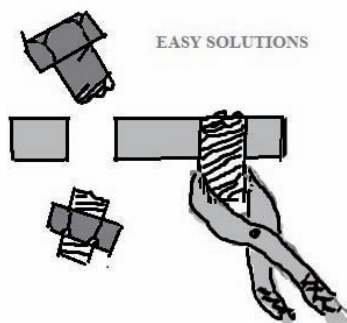
The most commonly encountered failure is that of a bolt which strips or breaks during assembly (we are looking at assembly problems for now but these solutions work for everyday problems as well). As mentioned before, a bolt that breaks and falls out of the joint because it was held by a nut on the opposite end can be easily replaced with another new bolt. It is prudent to check the area to see if any other damage was done. If

If the bolt breaks off but has part of the shank sticking out above the break or the threaded end sticking out below and is accessible, it may often be removed with a vise grip firmly clamped onto the remainder. If the break is flush, one solution is to drill a pilot hole and use a bolt extractor. This is a device that is inserted into the pilot hole, and as it is turned counter clockwise into the hole, it is also removing the bolt fragment. The device is available from most hardware sources. Replacement with a new, identical part is recommended.

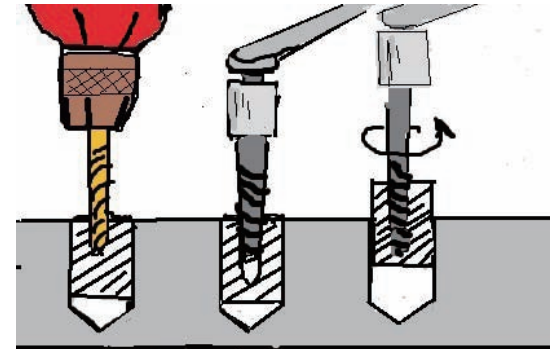
SCREW EXTRACTOR
Drill, Install Counterclockwise, Remove

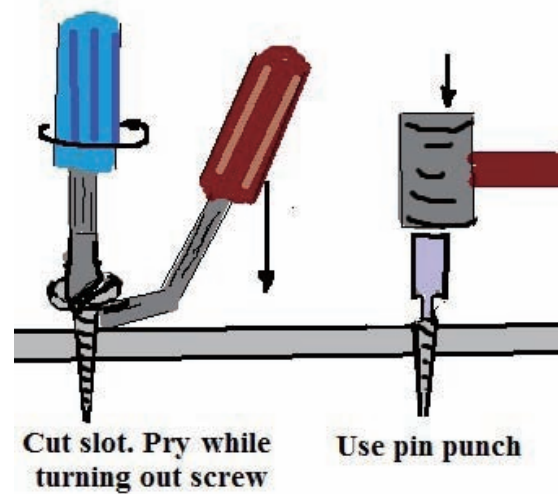
INSERT FOR STRIPPED THREAD REPAIR

The hole is drilled out, per instructions from the insert, and a special tap cuts a set of threads. The insert is threaded on both its outer and inner diameters. The inside thread of the insert matches the original thread of the damaged part. The insert is threaded in and a new original size bolt is threaded into the insert. This is often done in racing car engine where they desire a stronger thread strength than can be obtained from the cast iron engine block material.

In most instances the bolt is usually stronger than the internal threads so a repair to the tapped hole (if present) will be required (usually a re-tap to the next larger size). If the use of a larger size fastener is not possible, as in the case of an expensive component or a limited and costly item, a thread insert has been used successfully.

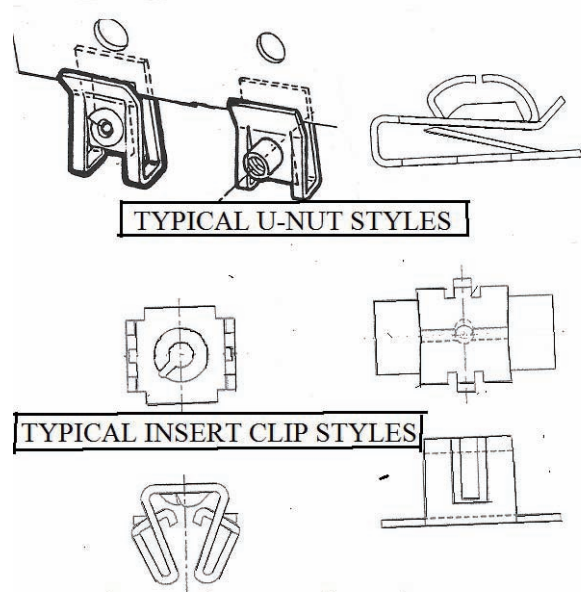
The u-nut clip has the advantage of higher strength, especially if a multithread style is used (example, the cone-like part shown here). The advantage of more than a single thread engagement is obvious.

Exact shape & style vary with manufacturers' patent

If size is an issue, screw failures can be repaired by using a metal clip with a formed feature to accept screw threads. Similar in construction to the many U-nuts in use today, these clips can replace screws which fail. For parts near edges the push on U-nut style is readily available. If the screw is located a distance away from an edge or if the hole is not large enough to accommodate U-Nut installation, an insert type snap-in clip design is available but will require lots of labor to install (make square hole, push in clip, install screw, and hope for the best). A solution but not very viable, as the parts have to be ordered, tooling available to cut holes, etc. This makes both for a non-workable solution, or if parts are to be on hand, a failure that must be corrected if that many occurrences happen.
